# **Five-Year Review Report**

**Third Five-Year Report**

**Apache Powder Superfund Site**

**Cochise County, Arizona**

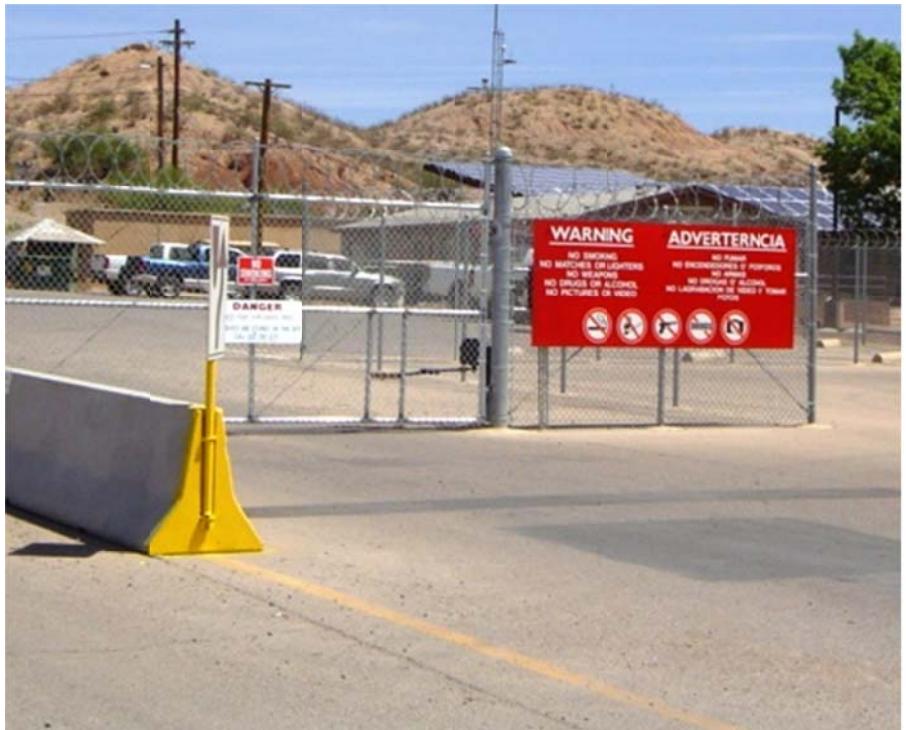
**Description:** The operations area of the ANPI facility is fenced with high-security fencing and locked gates, with a guard shack controlling all vehicle and pedestrian traffic.

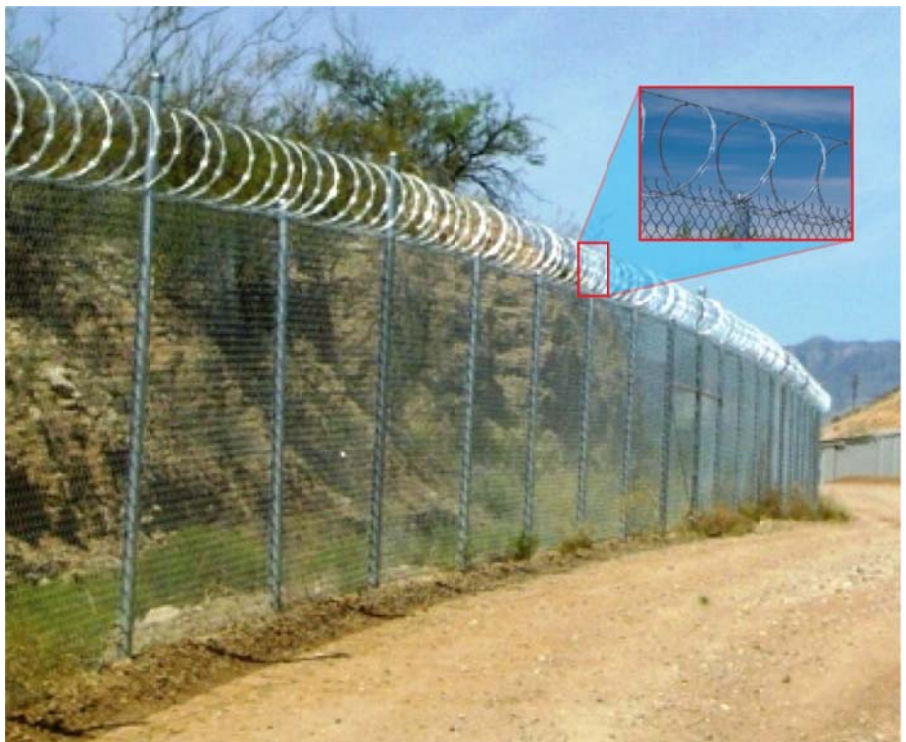
Photograph No. 2

**Description:** Photo depicts type of high-security fencing around operations area (inset shows razor wire). Fencing at the Wetlands area to prevent vehicle access only.

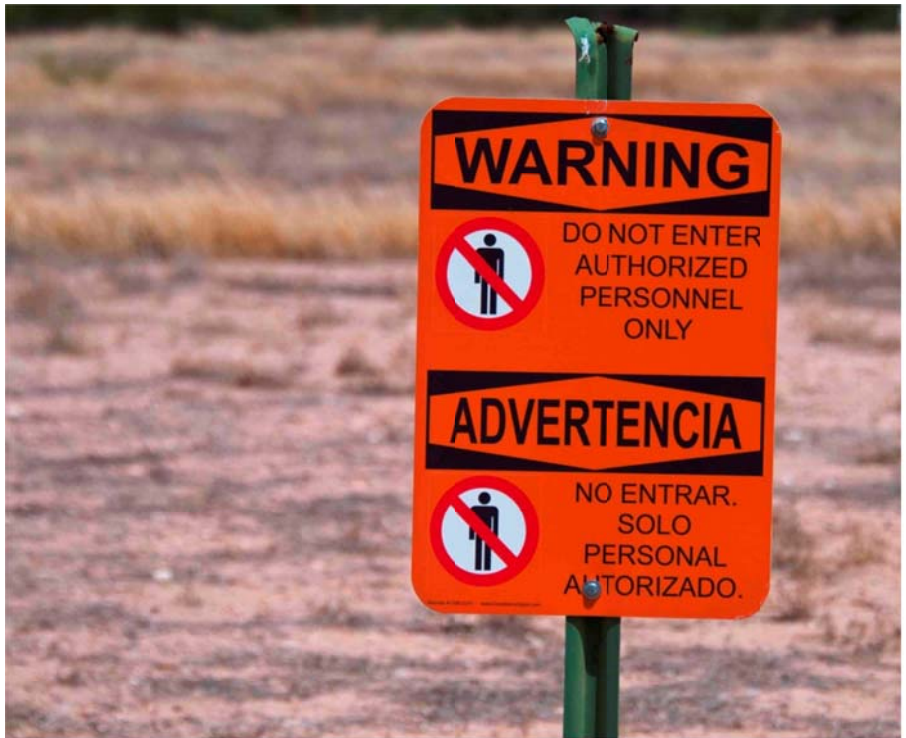
**Description:** This photograph shows typical signage at the ponds. Signs were in good condition and well placed.

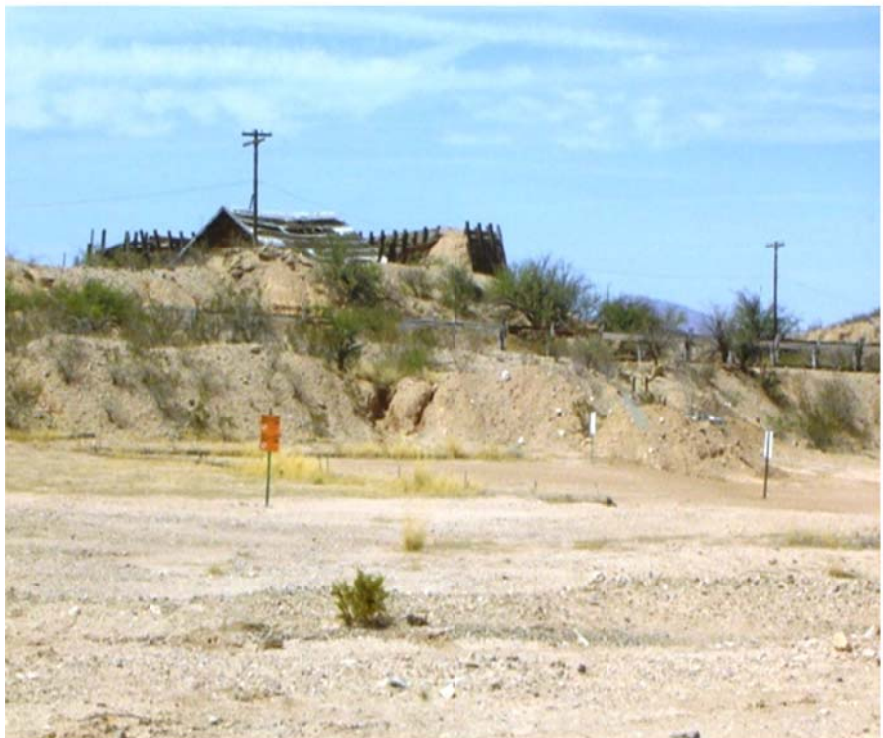
#### Photograph No. 4

**Description:** This photograph shows typical placement of signs around the perimeter of the ponds. (Orange shows front of signs and white shows back of signs.)

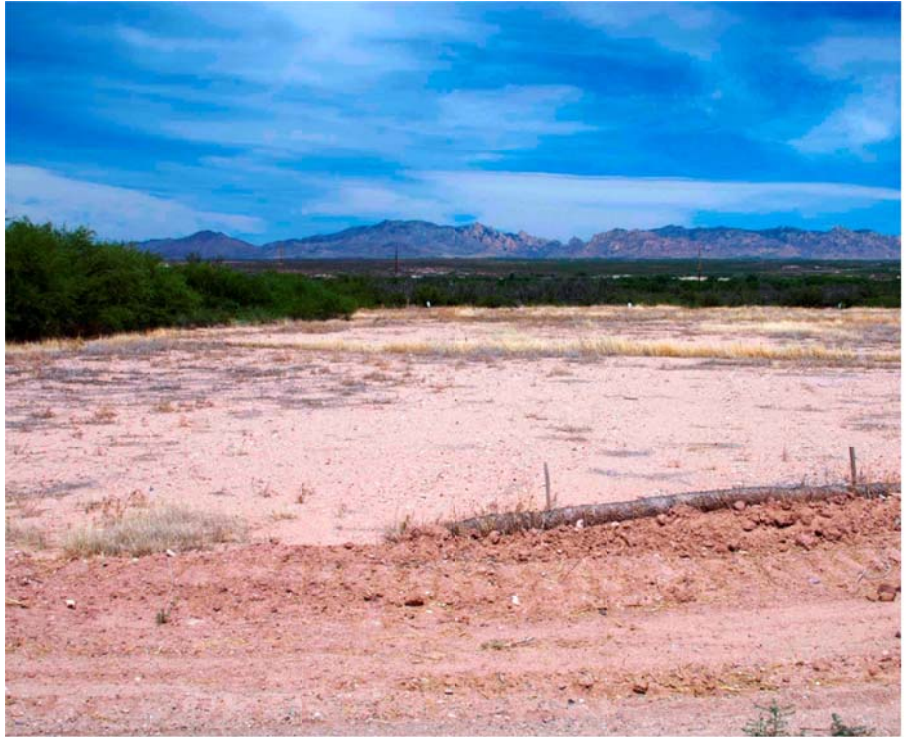
**Description:** This photograph represents a typical pond cover, well maintained with no erosion visible. Wattles help prevent erosion and define pond cover boundaries.

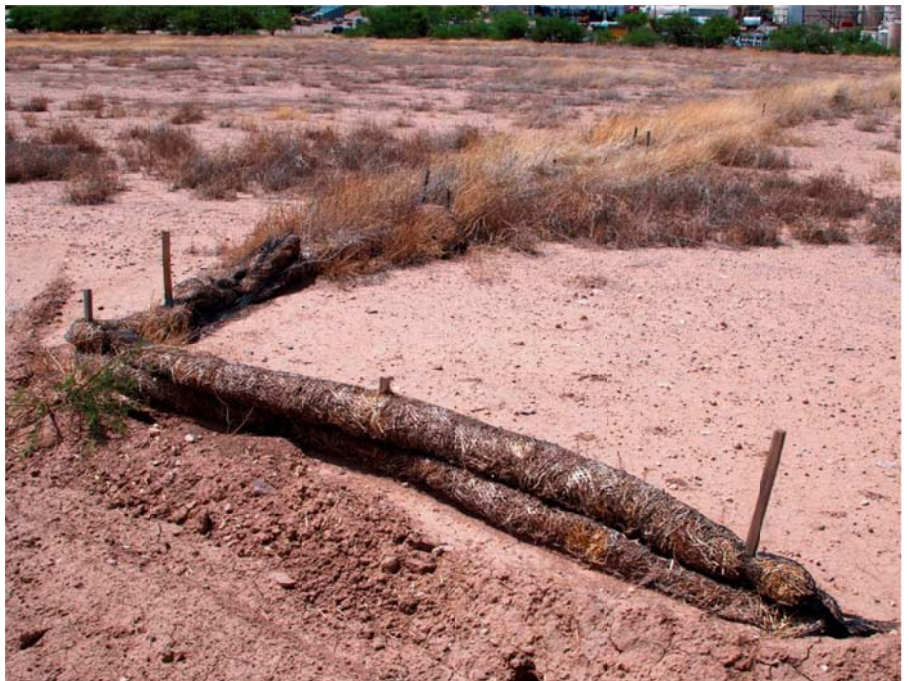
Photograph No. 6

**Description:** Wattles are in place and well maintained to protect the pond covers from erosion and vehicular traffic. When wattles begin to deteriorate a new one is placed on top and the two are staked together as shown here.

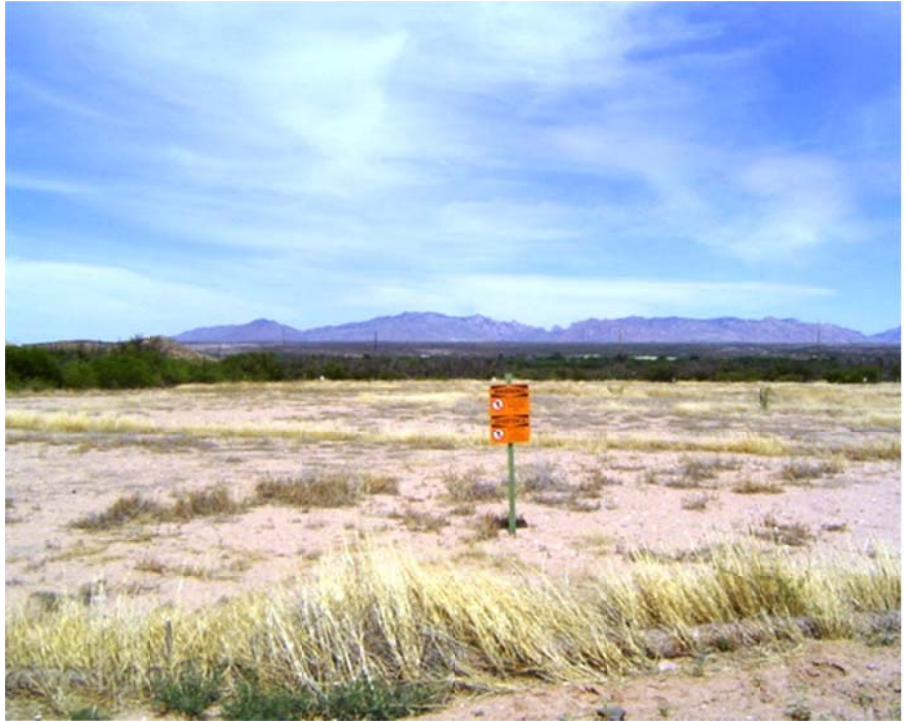
**Description:** Native vegetation is taking hold on the pond covers. Typical native vegetation is shown in the photograph.

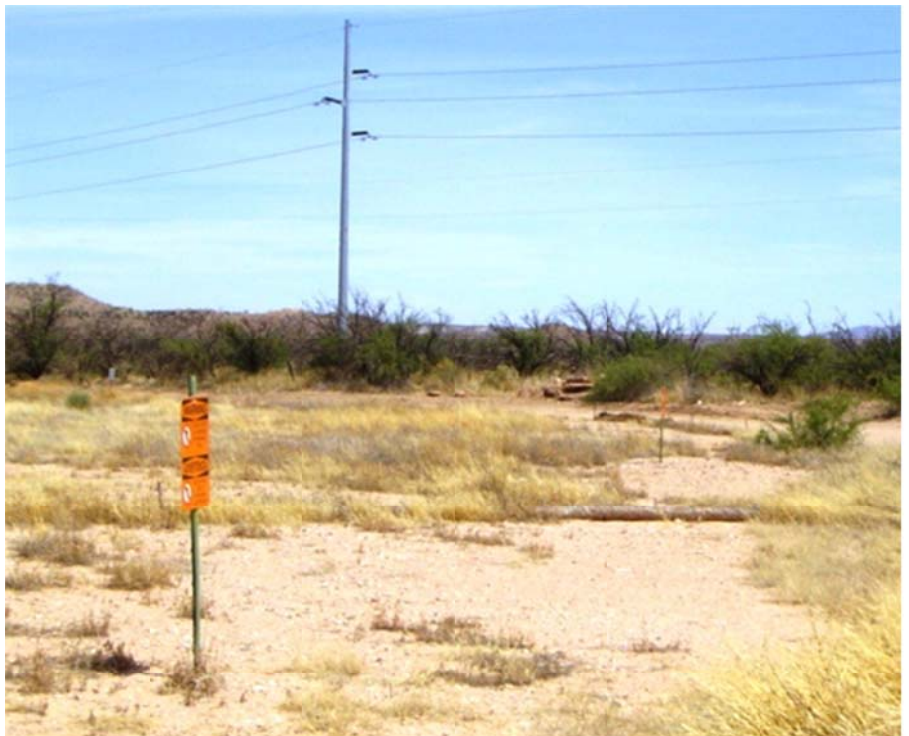
#### Photograph No. 8

**Description:** In some areas, native vegetation is taking hold on the pond covers including native bushes and trees in some areas.

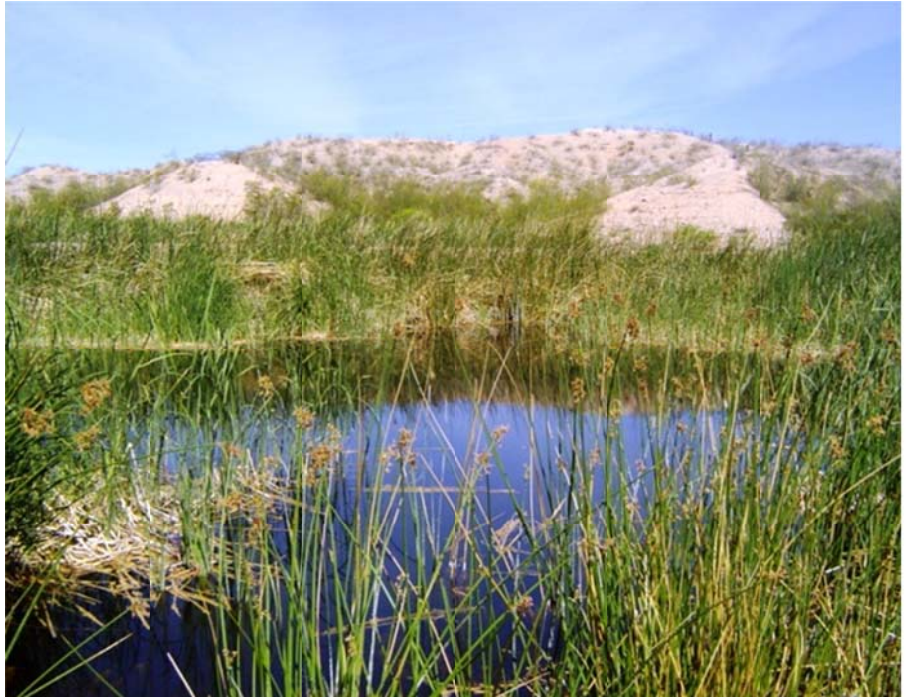
**Description:** The Wetlands appear healthy and continues to be a successful remedy for nitrate contaminated groundwater.

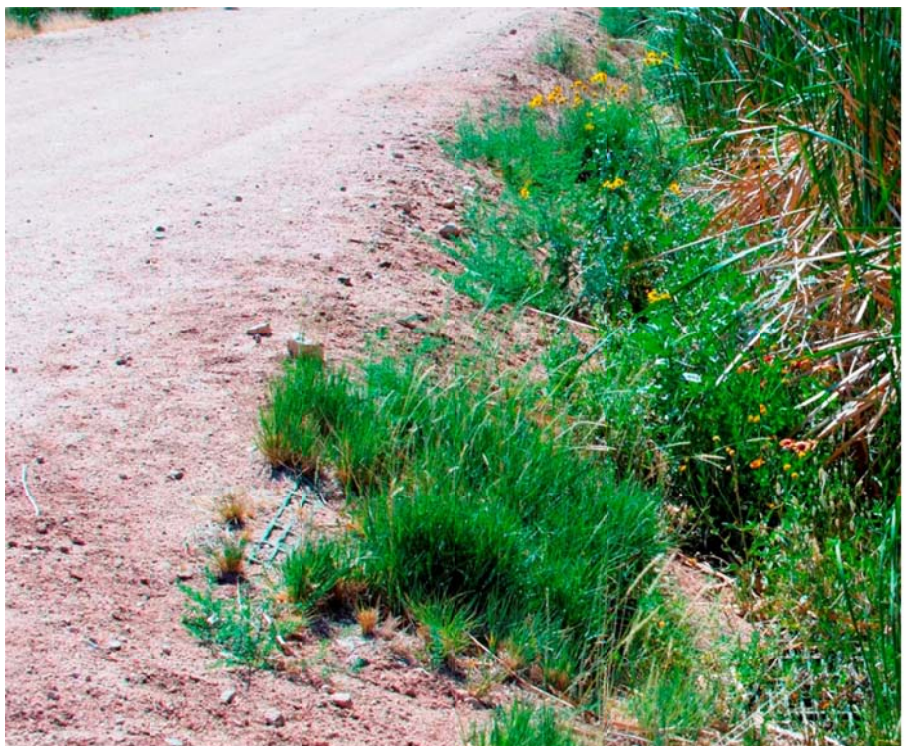
Photograph No. 10

**Description:** Successful hydro-seeding, done in 2011, provides native grasses and flowers along the slopes into the ponds (treatment cells), preventing erosion along the slopes. .

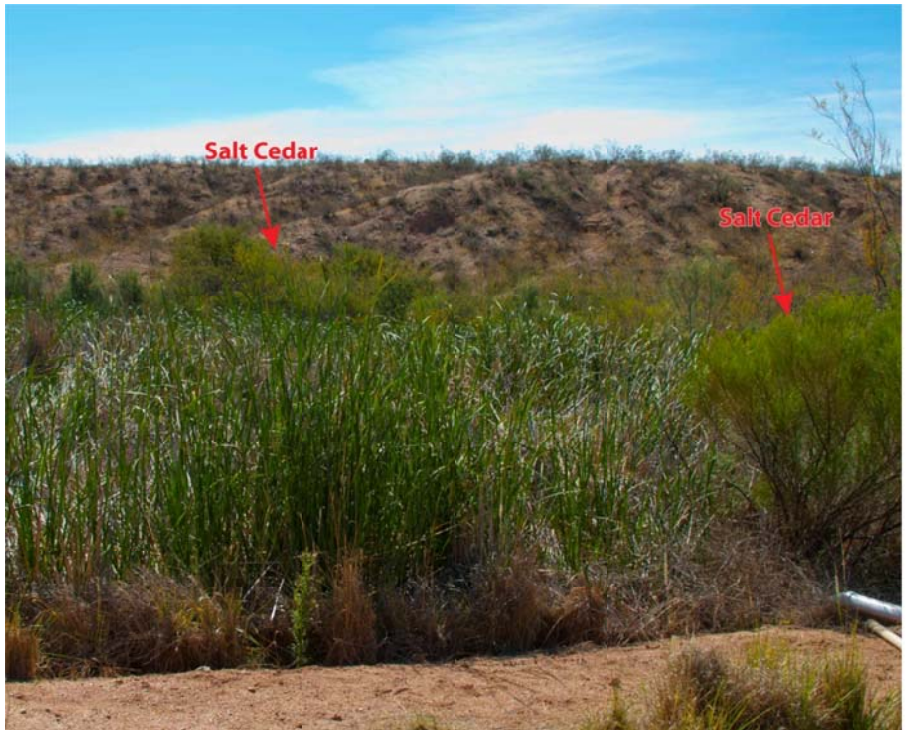
**Description:** Salt cedar (see arrows) and Tamarisk (not shown), both invasive species, must be continually maintained.

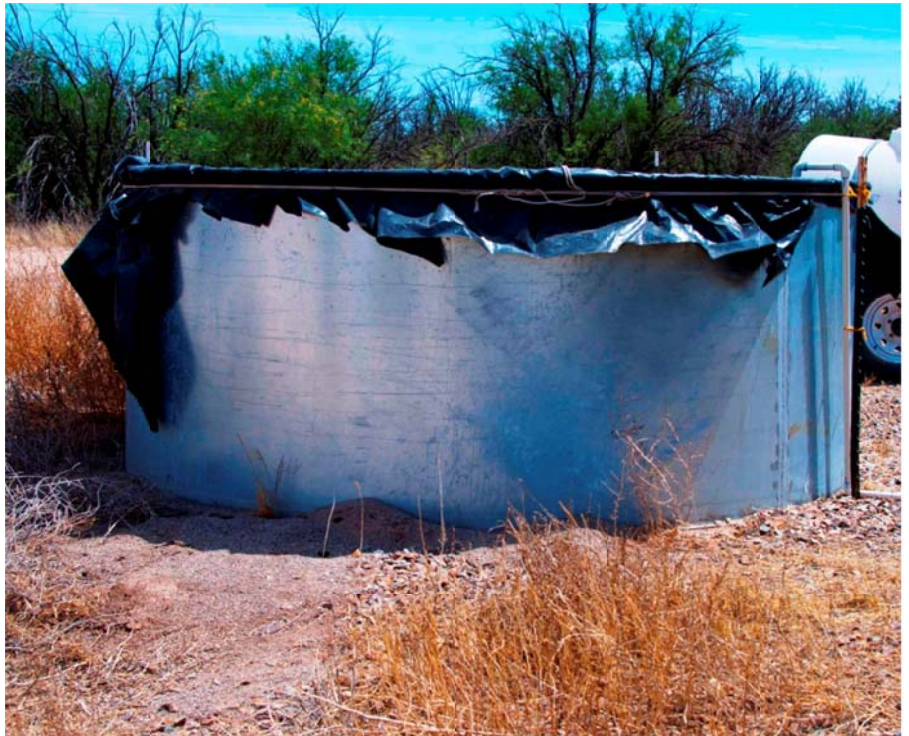
**Description:** One of two tanks used to collect water pumped from the perched aquifer is shown here.

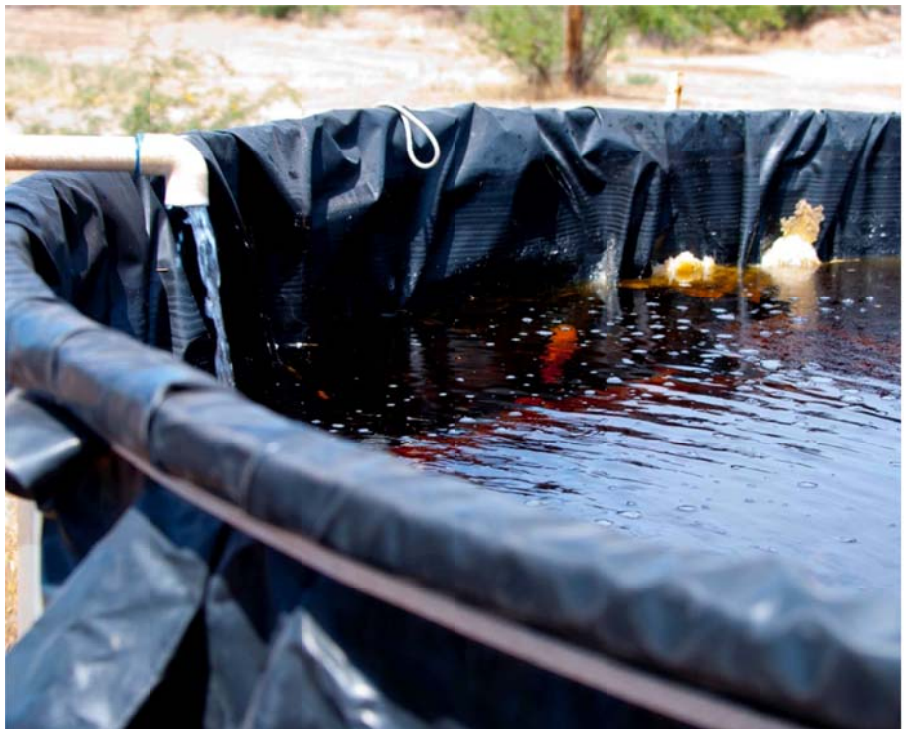
Photograph No. 14

**Description:** Interior view of a water collection tank for the perched system with the water pump operating.

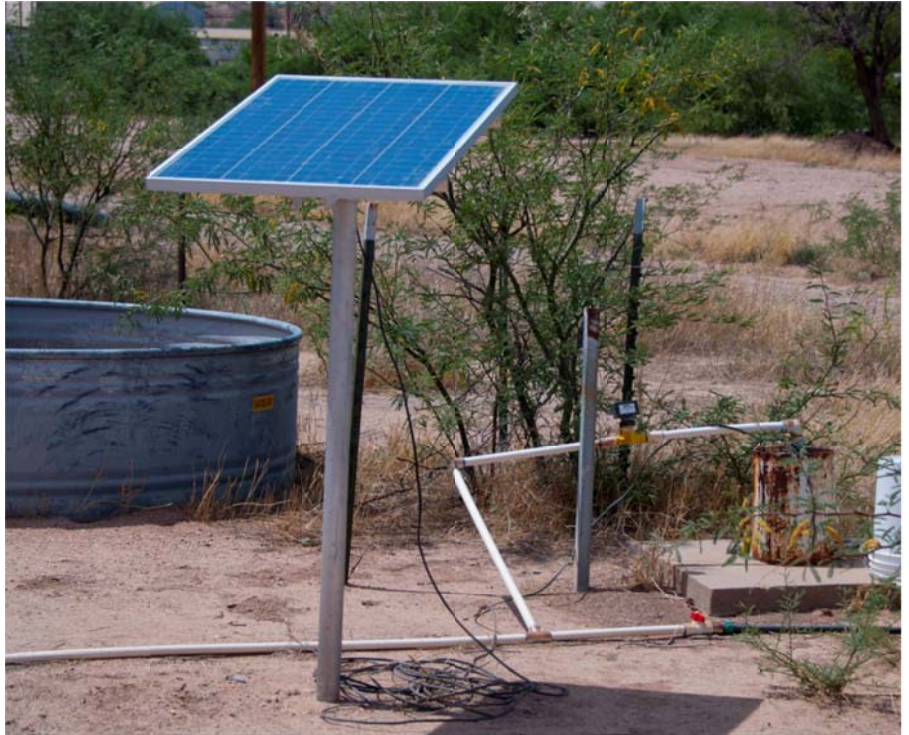
**Description:** Solar panel used to operate water pump. (Shallow evaporation pan shown on the left is no longer in use; however, should be reconsidered to maximize evaporation).

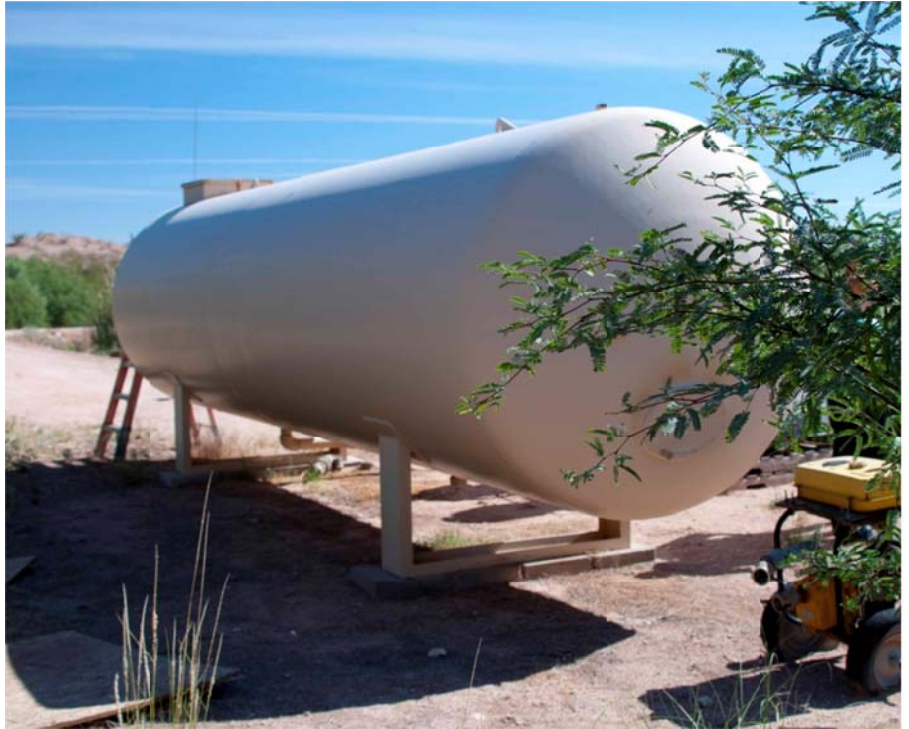
**Description:** Permanent 5,000-gallon molasses storage tank located at the Wetlands. Molasses from this tank is pumped into the 500-gallon trailer-mounted tank shown in photograph number 17.

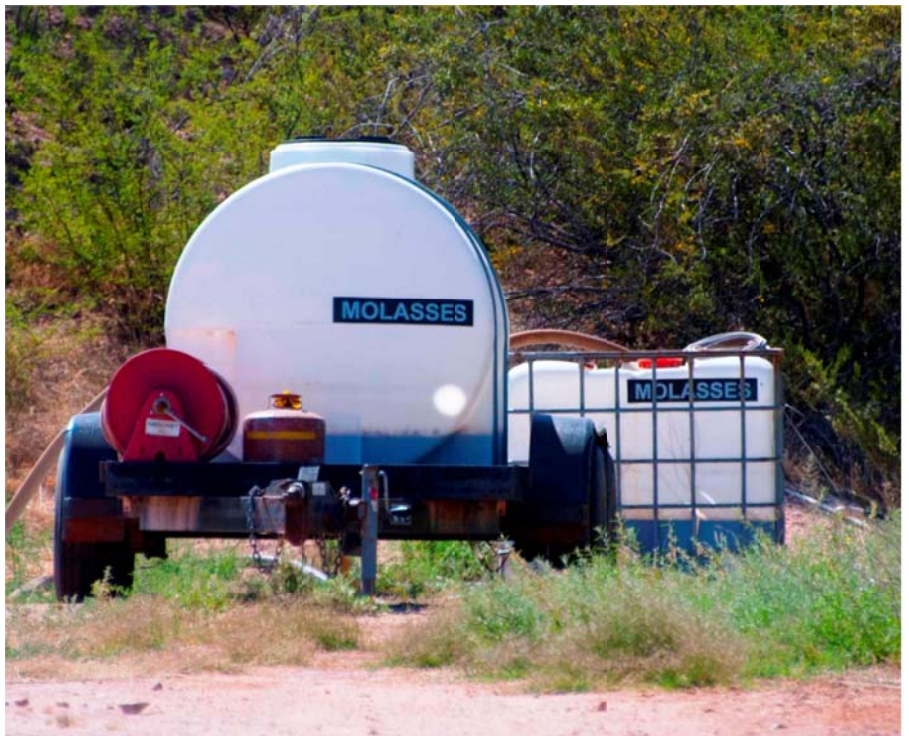
Photograph No. 18

**Description:** Trailer-mounted 500-gallon molasses tank. This trailer-mounted tank transports molasses from the 5,000-gallon permanent tank in photograph 12 to be pumped into the portable 250-gallon totes, shown on the right side of the photograph.

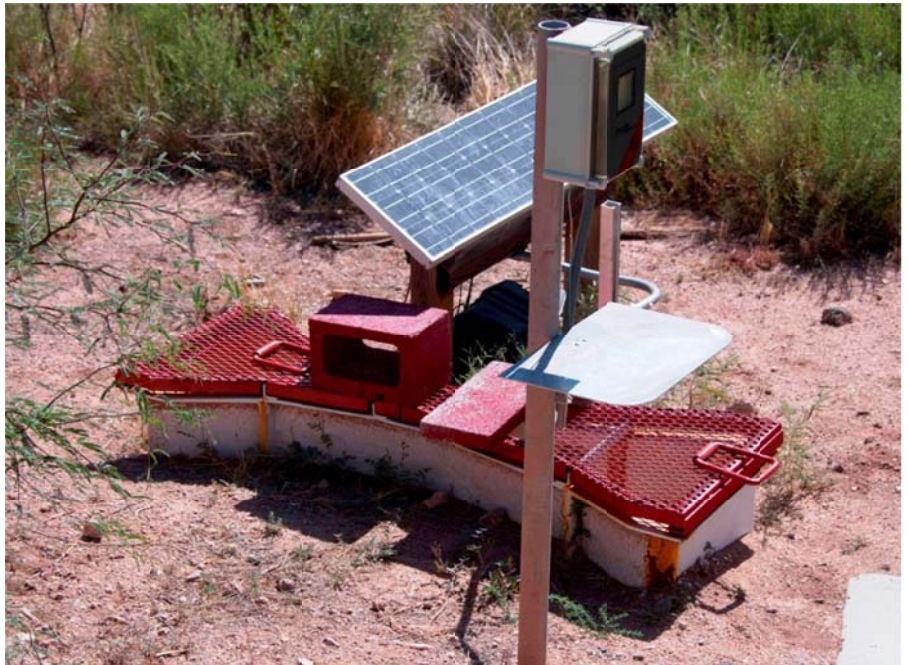
**Description:** Flow Meter to measure effluent discharge from the Wetlands is powered by renewable energy from a solar cell. Monitor wells and associated pump-and-treat equipment were found to be in good shape and in working condition.

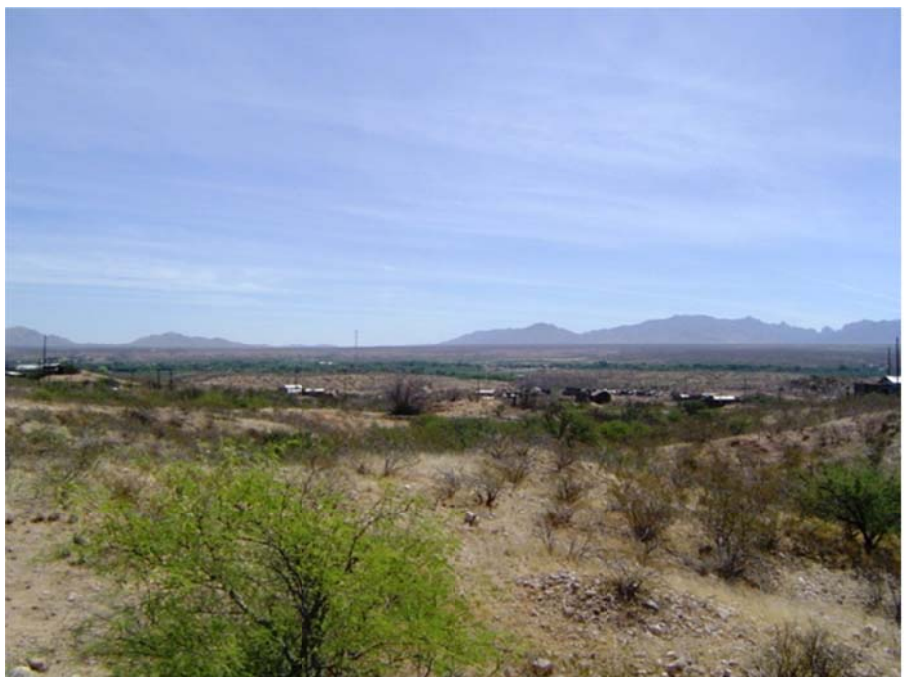
Photograph No. 20

**Description:** The row of buildings shown built into the sides of the hills is known as the "Powder Line". Dynamite sticks were assembled in them for Apache Powder beginning in the early 1920's. The idea was that if an explosion occurred, only the one building would be.

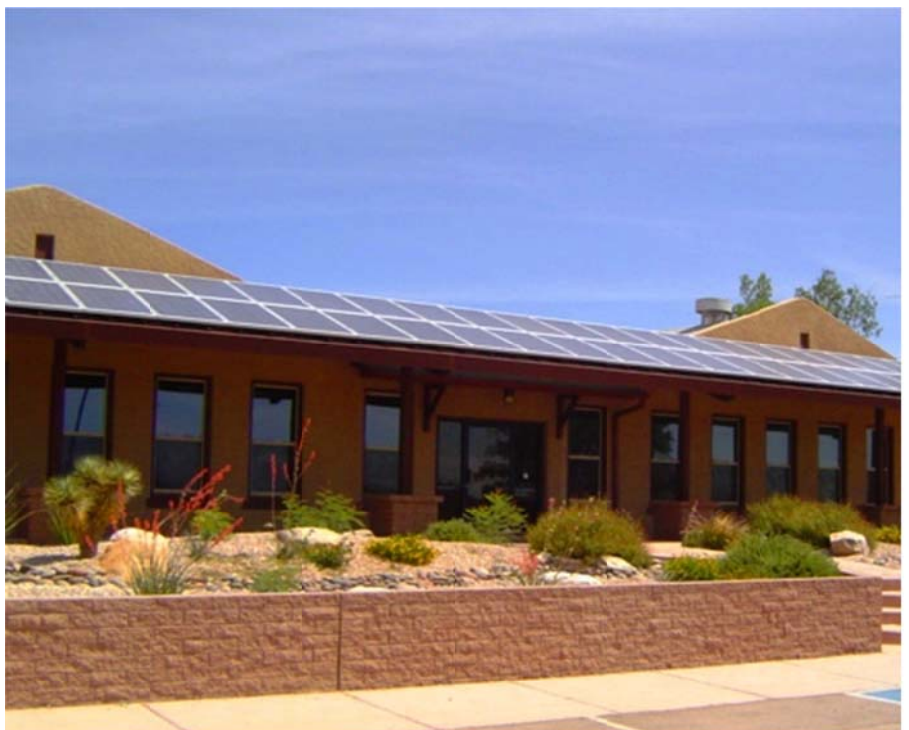
Photograph No. 23

**Description:** ANPI constructed a solar canopy over the front of the main administration building. The solar panels provide renewable energy and off-sets power needs for the building.

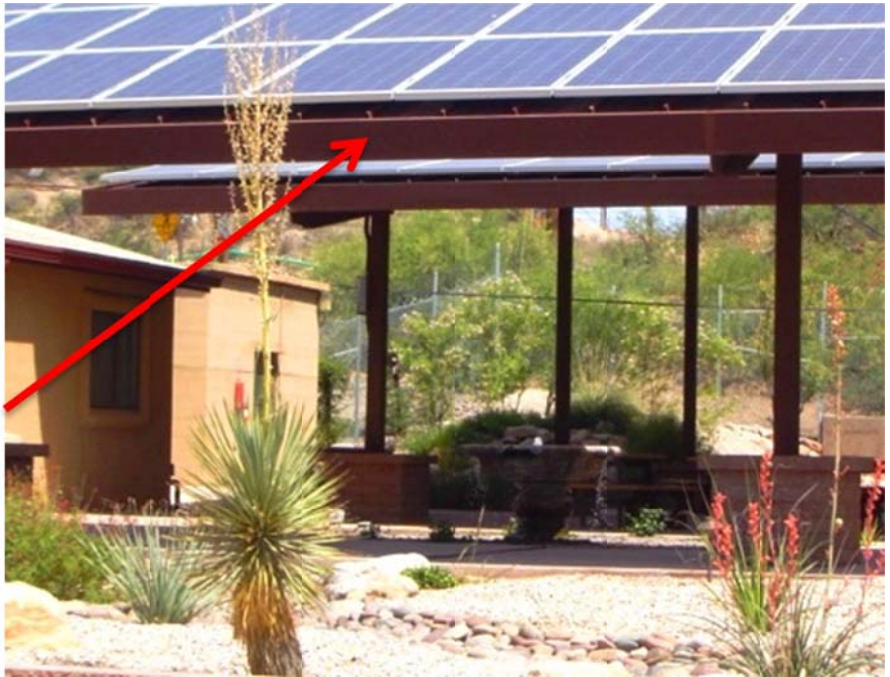
**Description:** ANPI utilizes gutters placed along the roofs of the main office buildings to harvest rain water. This water is used to fill the fountain located on an outside patio. Water is also used to maintain the Xeriscape.
